NORDKYSTENS FREMTID

Intermunicipal coastal protection project

11-10-2022 Signe Schløer

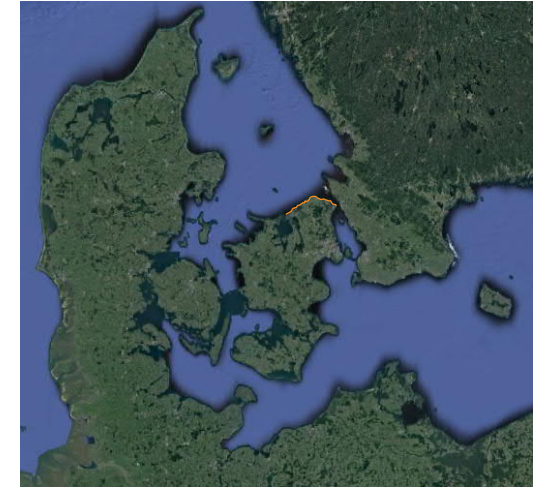
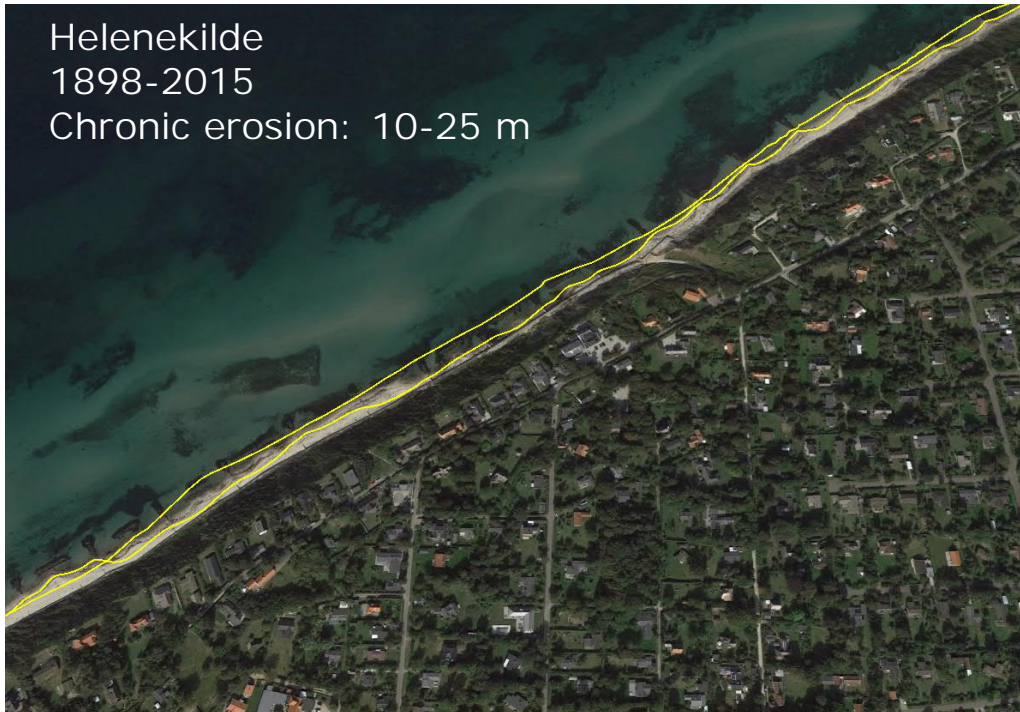
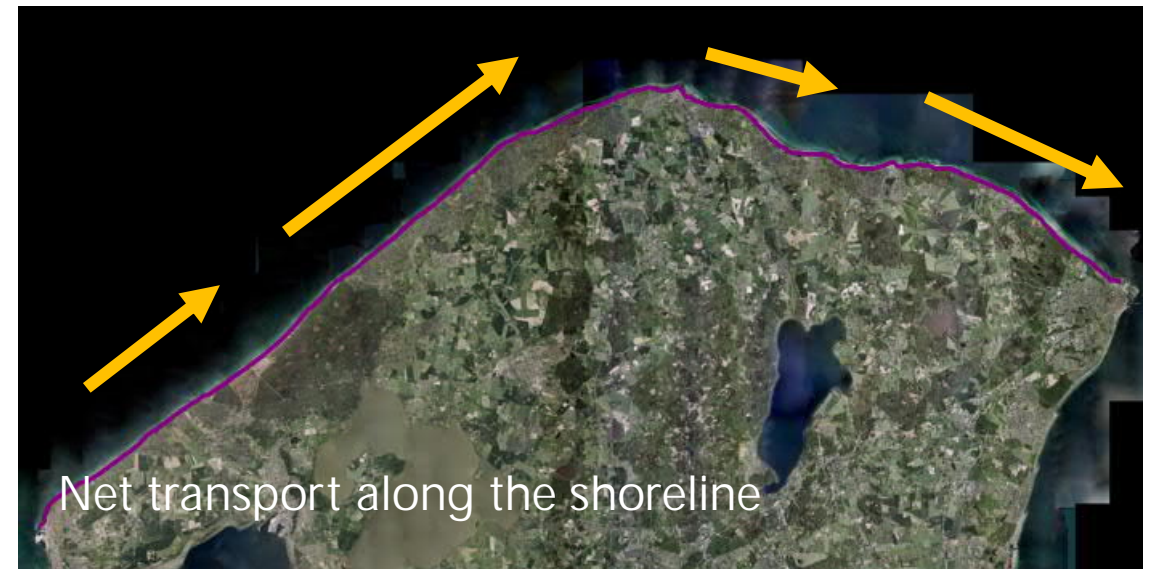
North coast of Zealand

- Chronic coastal erosion
- Net sediment transport from Hundested to Helsingør
- Developed part protected with coastal protection (revetments)

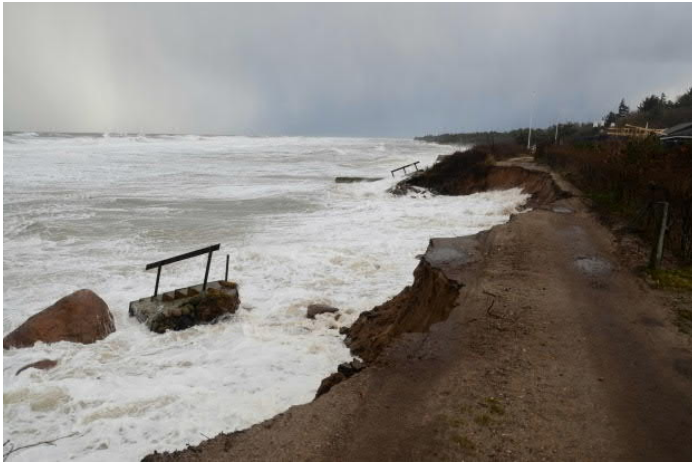
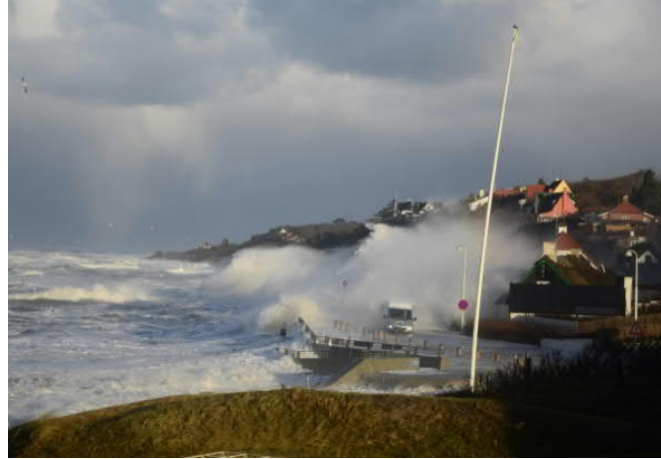
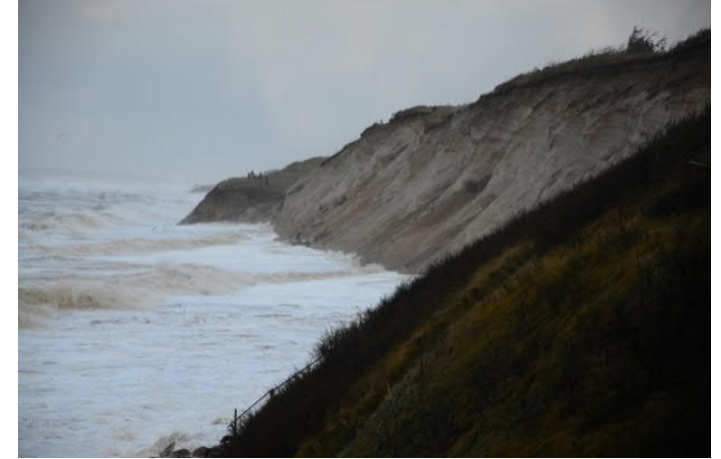
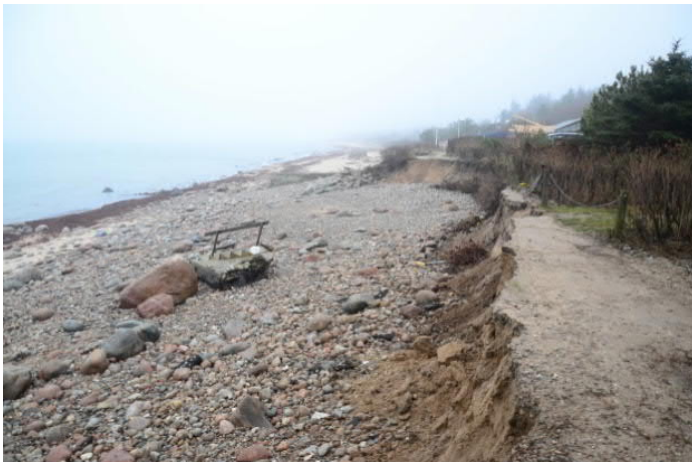
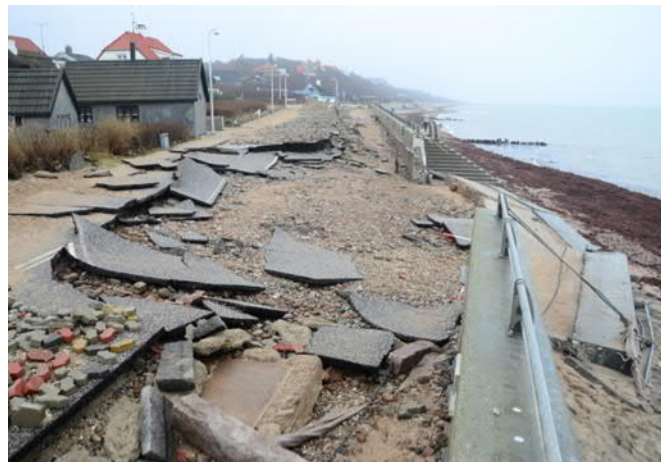
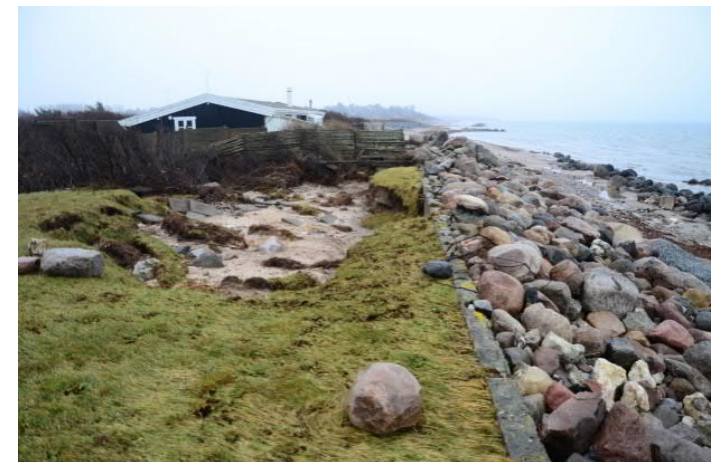
Pictures after the storm Bodil / Sven 6/12-2013

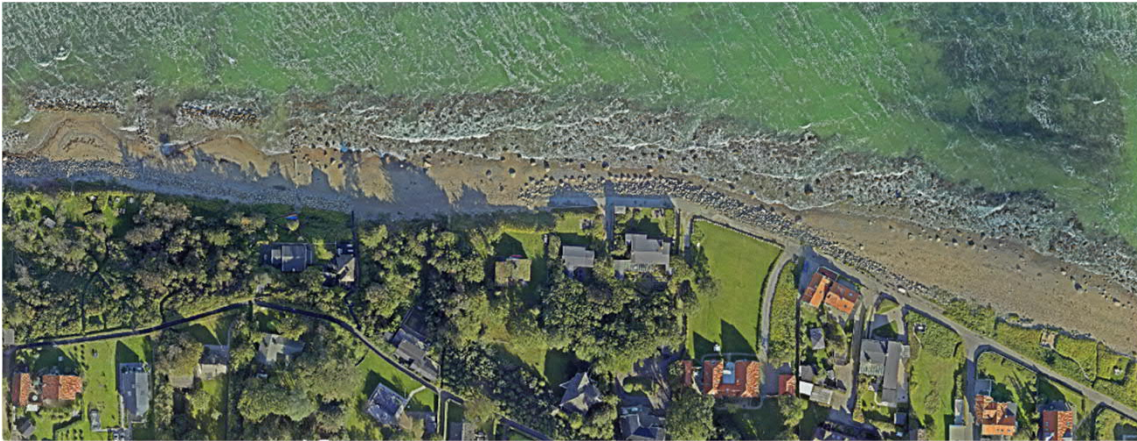
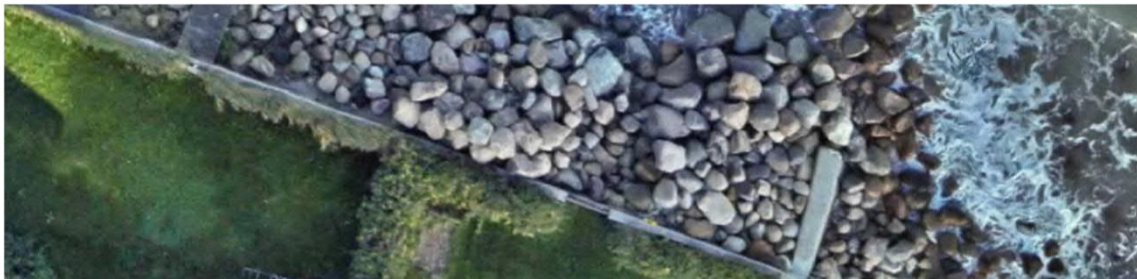
Topographical survey – LiDAR and orthophoto

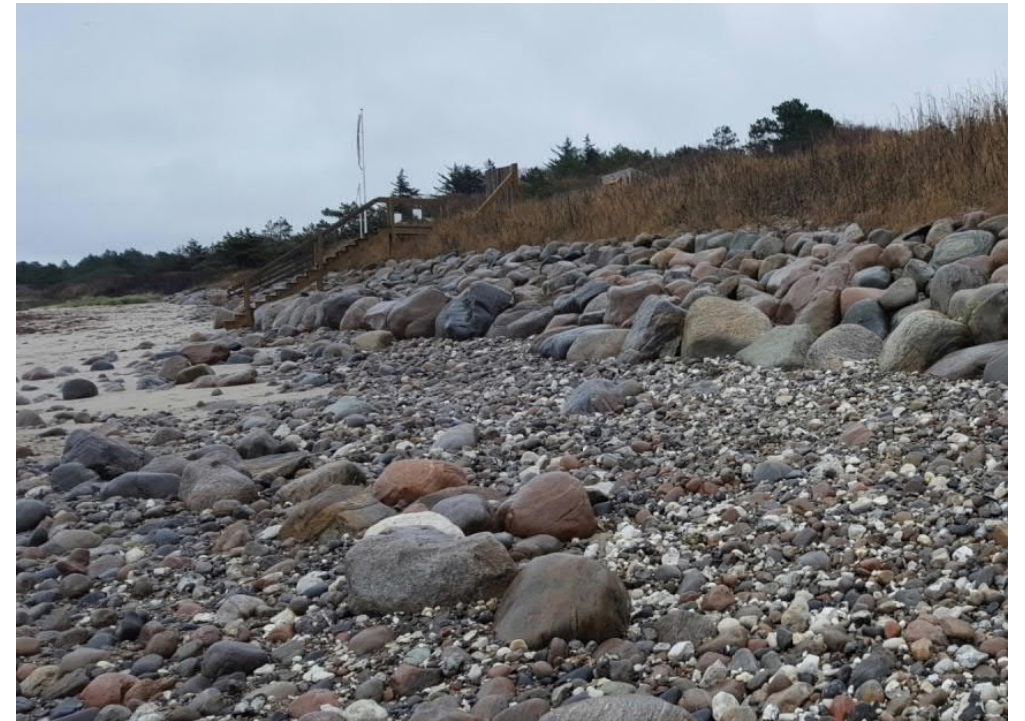
Registration of existing constructions

40/80 cm
Collapsed
St. 28350

40/100 cm, 1/2.05
Rocks largest in the bottom
St. 28310-28400

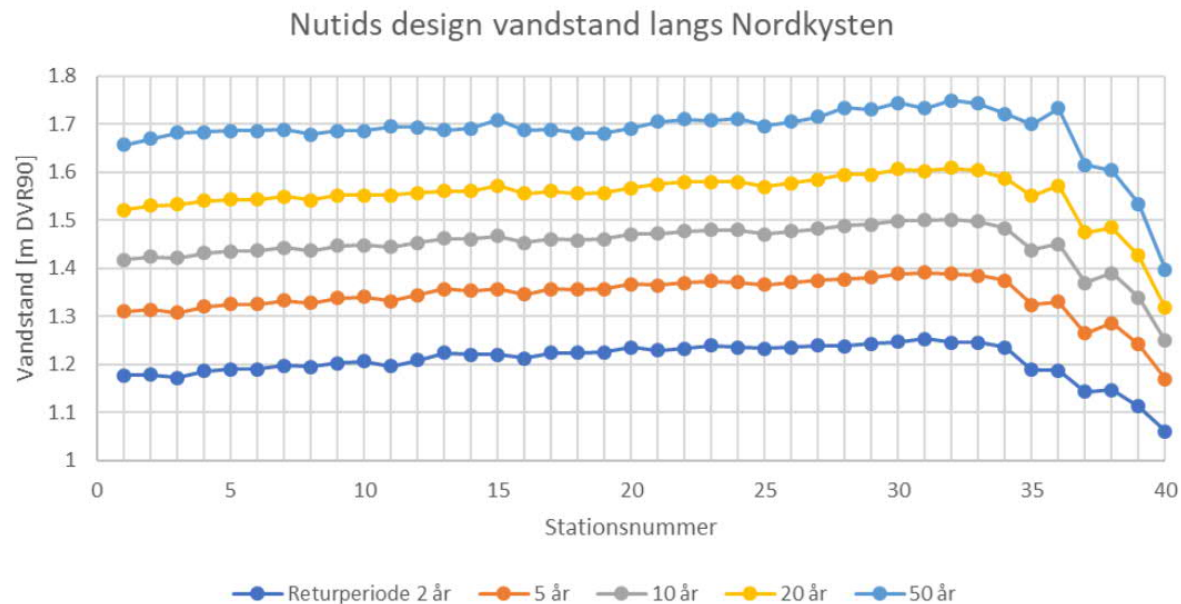
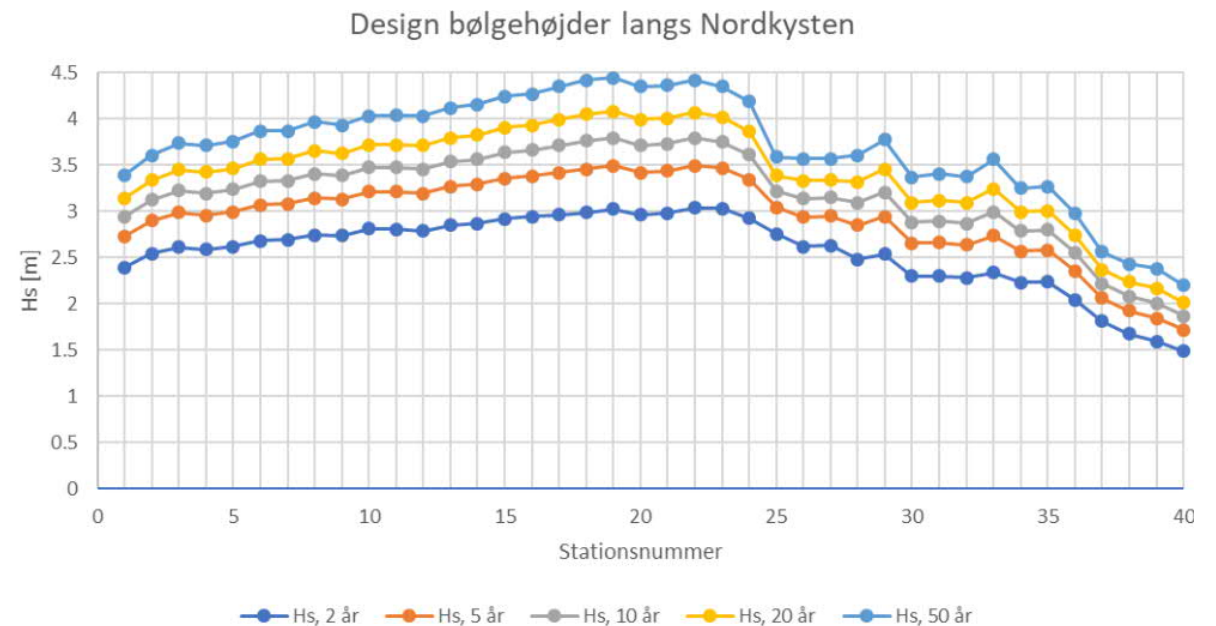
Extreme value analysis

- Water levels (~1.7 m)
- Wave heights (4.4 and 3.6 m)

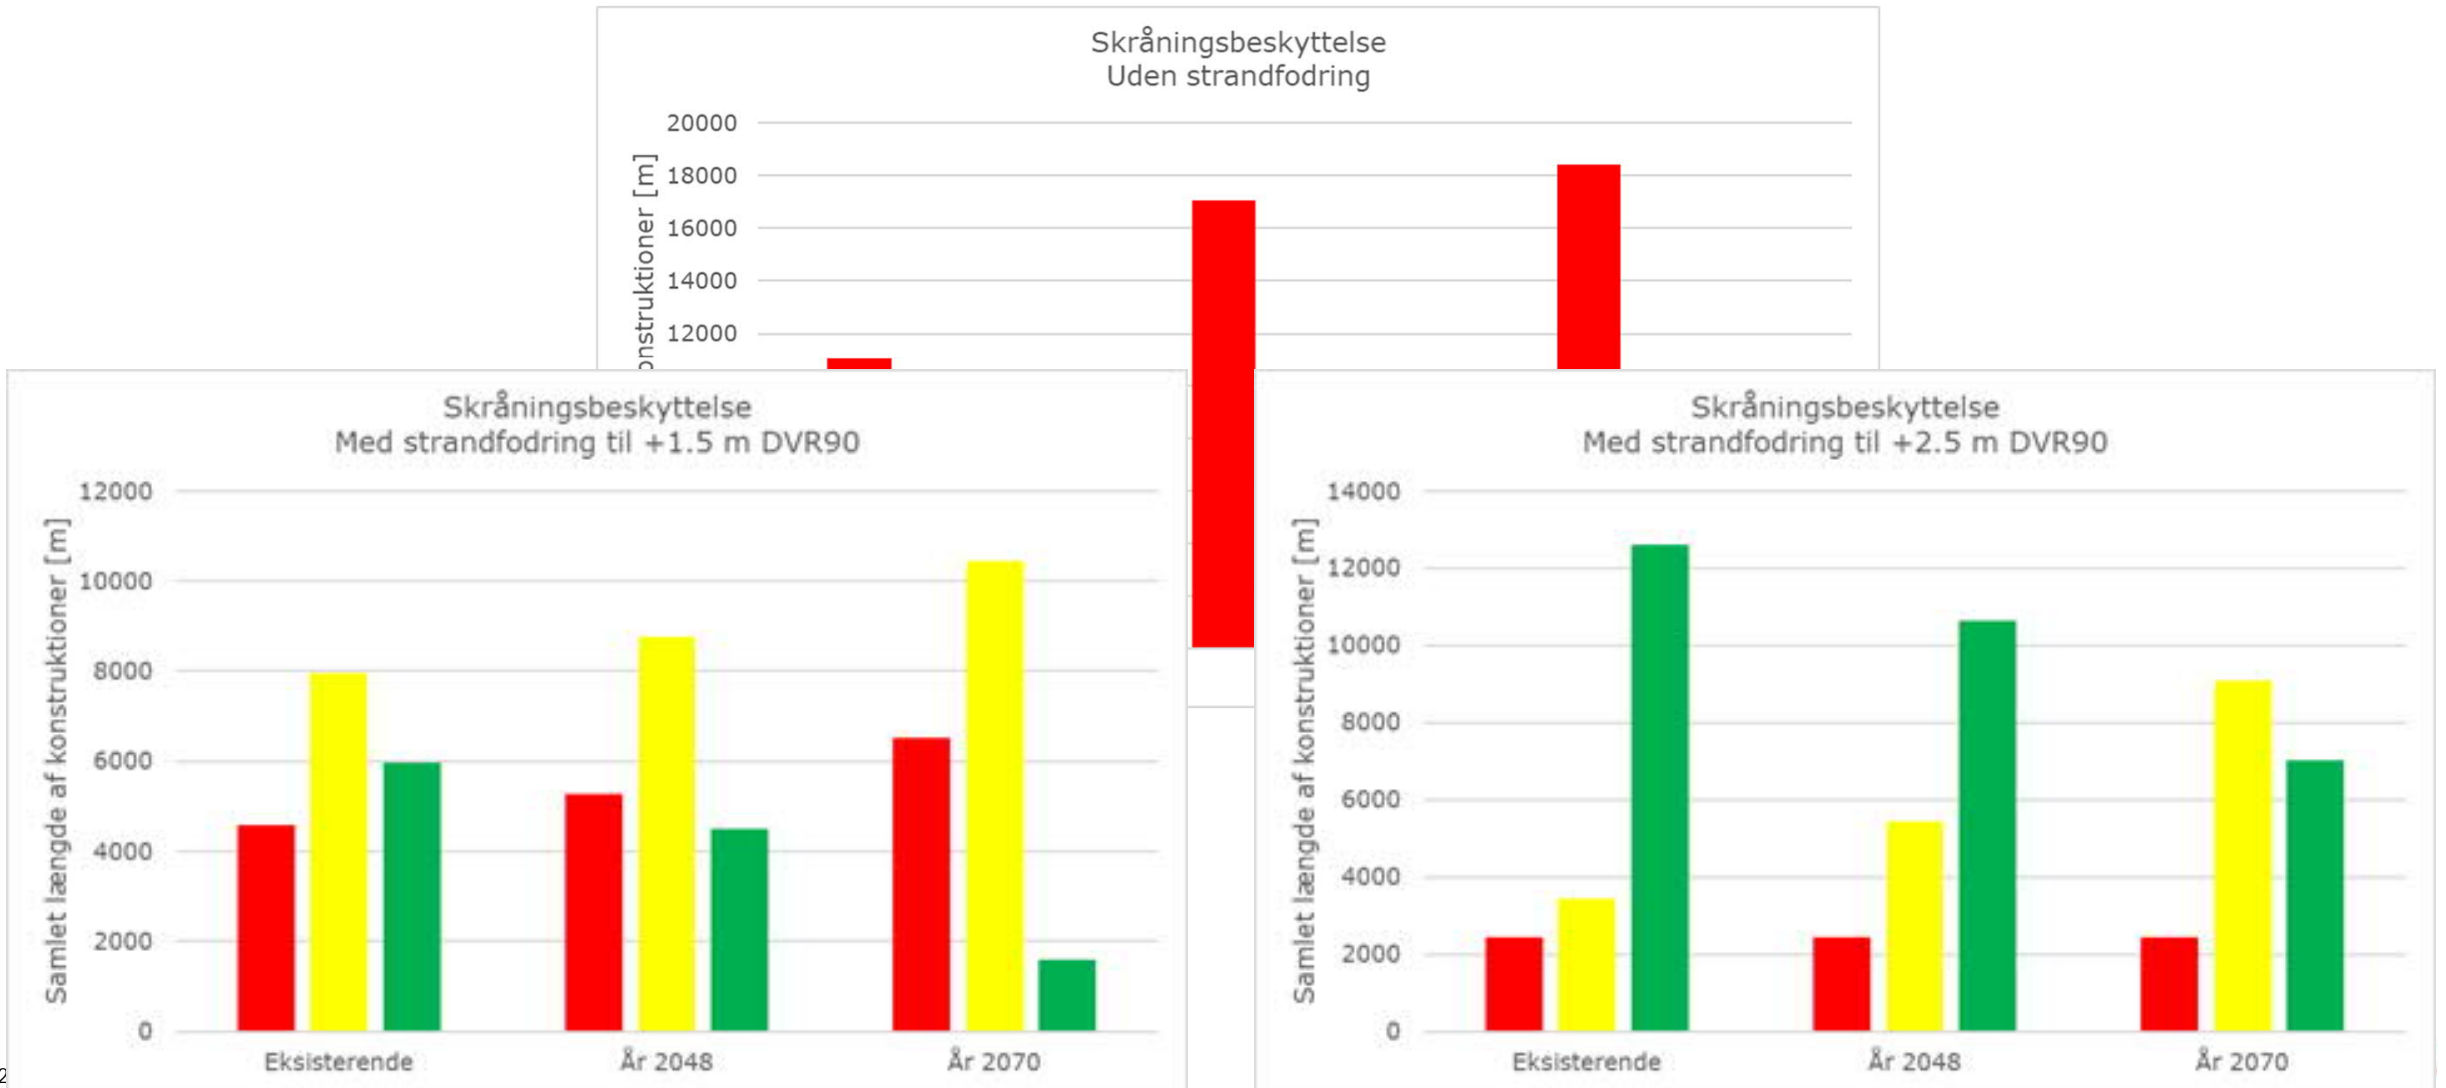
Today and in 50 years with beach nourishment
